Evaluating accidents in the offshore drilling of petroleum: Regional picture and reducing impact

ABSTRACT

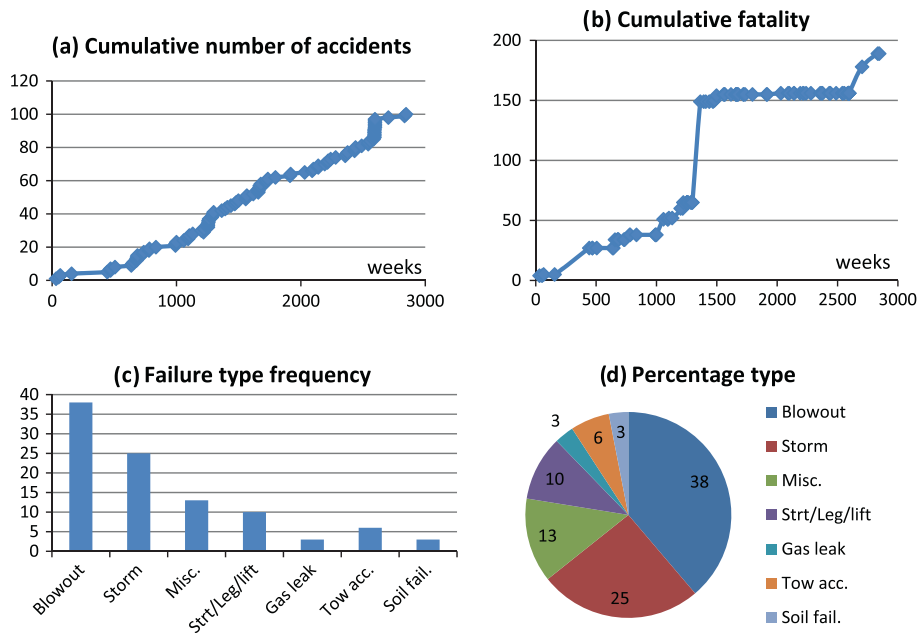
Table 1 shows details of some of the prominent accidents from N America region including the time lapse in weeks after the zero hour of 1 January 1956 and the number of fatalities associated with each accident. In the current study the accident types (or causes) are grouped into blowouts, towing accidents, running aground, structural failures, gas leaks, storms, soil failures, and others. Fig. 1a shows that over the study period there were a total of 98 recorded accidents. There is an indication of a regular changing slope every about 8–10 years. Fig. 1b shows a cumulative number of fatalities of 188 with a maximum of 84 recorded by the semi-submersible Ocean Ranger flooding. Fig. 1c shows that out of 98 accidents, 38 or 38.8% were due to blowouts followed by 25 or 23.4% caused by storms. Structural failures made up 10.2% and towing accidents made up 6.1%. Fig. 1d is the pie-chart showing the percentage distribution of the basic causes.

Fig. 1. Accidents type and frequency and fatality (N America).

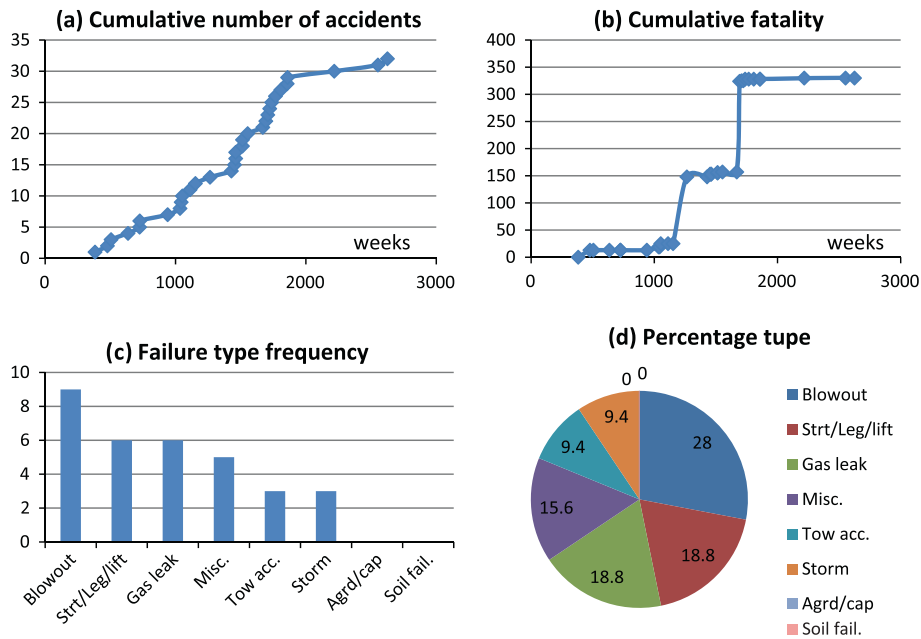
Table 2 shows details of some of the prominent accidents from the European and North Sea region including the time lapse in weeks after the zero hour of 1 January 1956 and the number of fatalities associated with each accident. In the current study the accident types (or causes) are grouped into blowouts, towing accidents, running aground, structural failures, gas leaks, storms, soil failures, and others. Fig. 2a shows that over the study period there were a total of 32 recorded accidents. There is an indication of a regular changing slope every about 9–11 years. Fig. 2b shows a cumulative number of fatalities of 330 with a maximum of 167 recorded by the platform Piper Alpha fire and explosion in the North Sea. The figure shows that there is a clear change in the trend in both the numbers of accidents and fatalities recorded after the Piper Alpha disaster. This could be due to positive developments in Regulations following the Cullen Report. Fig. 2c shows that out of 32 accidents, 9 or 28% were due to blowouts followed by 6 each or 18.8% caused by gas leaks and structural failures. Storms and towing accidents made up 3 each or 9.4%. Fig. 2d is the pie-chart showing the percentage distribution of the basic causes.

Fig. 2. Accidents type and frequency and fatality (Europe).

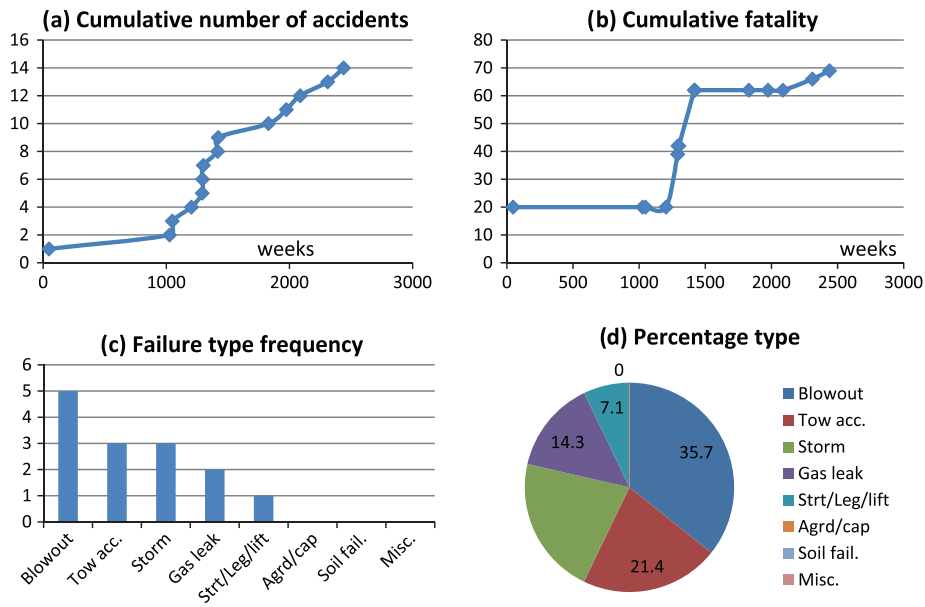
Platform blowout the trend in the frequency of accidents does not seem to change. Fig. 3c shows that out of 14 accidents, 5 or 35.7% were due to blowouts followed by 3 each or 21.4% each caused by towing accidents and storms. There were 2 gas leaks or 14.3% and 1 structural failure or 7.1%. Fig. 3d is the pie-chart showing the percentage distribution of the basic causes.

Fig. 3. Accidents type and frequency and fatality (Middle East).

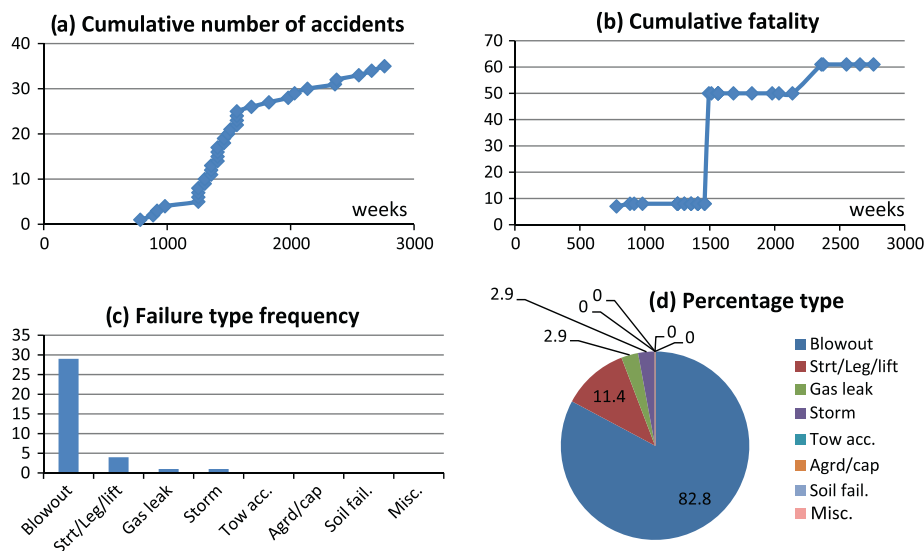
Fig. 4. Accidents type and frequency and fatality (South America).

Fig. 4d is the pie-chart showing the percentage distribution of the basic causes.

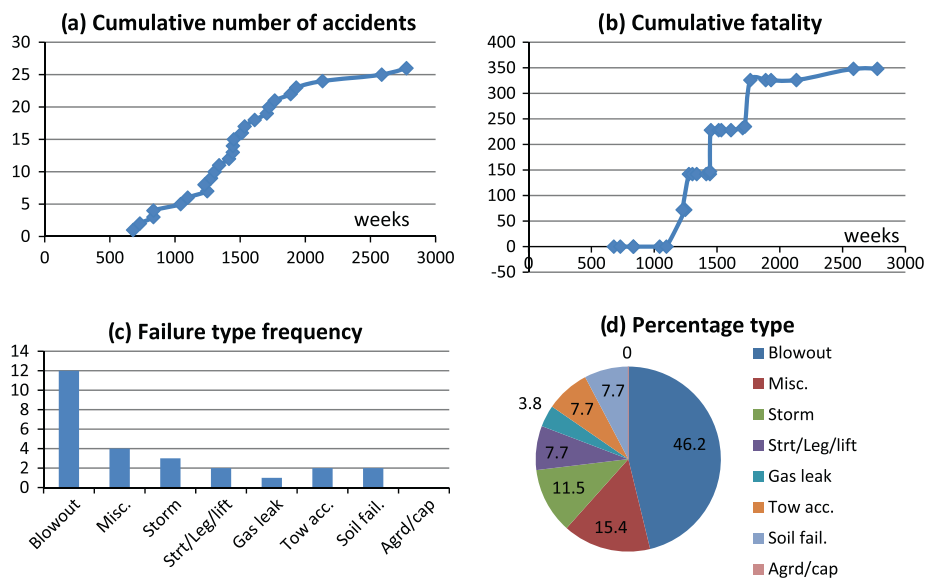
Fig. 5c shows that out of 26 accidents, 12 or 46.2% were due to blowouts and 3 or 11.5% caused by storms. There were 2 accidents caused by structural failure, towing activities and soil failures or 7.7% each. There was 1 or 3.8% accident caused by a gas leak. Fig. 5d is the pie-chart showing the percentage distribution of the basic causes.

Fig. 5. Accidents type and frequency and fatality (Asia/Australasia).

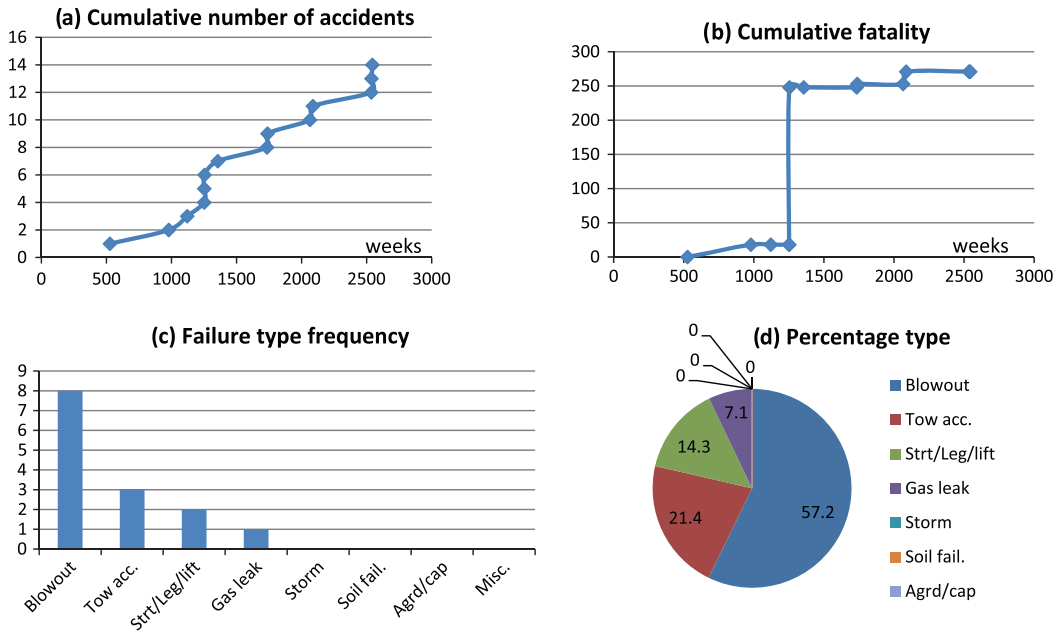
There was no indication of any trend in the frequency of accidents. Fig. 6c shows that out of 14 accidents, 8 or 57.2% were due to blowouts followed by 3 or 21.4% due to towing accidents. There were 2 or 14.3% accidents caused by structural failure and 1 or 7.1% accident due to a gas leak. Fig. 6d is the pie-chart showing the percentage distribution of the basic causes.

Fig. 6. Accidents type and frequency and fatality (N America).

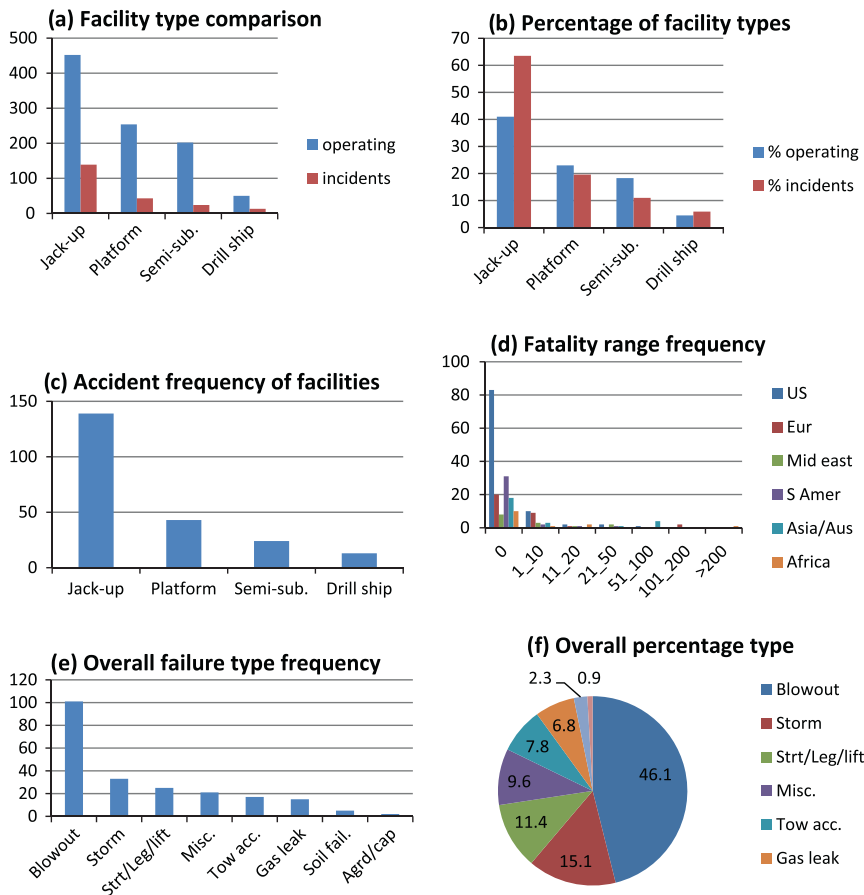
Fig. 7a shows the summary of the number of operating facilities as from 1991 to date and the number of accidents recorded in this study. Jack-ups represent the biggest number of operating facility type followed by platforms, semi-submersibles and drill ships. There is a corresponding trend in the frequency of accidents in relation to the numbers of facility types in operation. Fig. 7b shows the percentage of the various types of facilities in operation and the percentage of those types involved in incidents. It is apparent that jack-ups have a disproportionately higher rate of failures compared to platforms and semi-submersibles. This could be due to the less stable operating conditions for the jack-ups. Fig. 7c shows the total frequency of incidents for each type of facility involved in this study. Fig. 7d shows the frequency for various fatality ranges. The majority of accidents involved no fatalities. The trend shows the higher the range of fatality, the less

Fig. 7. Summary of overall frequencies, failure types and fatalities.

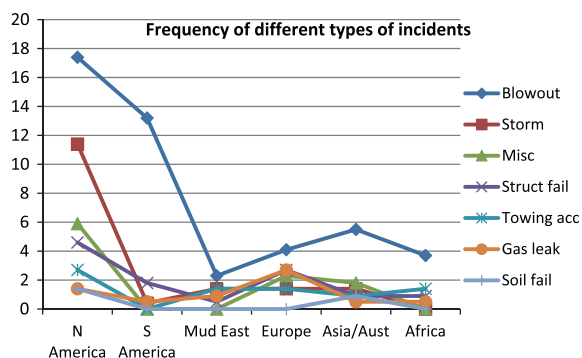
Fig. 8. Frequencies as percent of total global figure of accidents: by region.
